**CULTURAL RESOURCE ASSESSMENT SURVEY UPDATE  
TECHNICAL MEMORANDUM**

**For One New Right-of-Way (ROW) Parcel For**

**I-275/SR 93 SB/I-4/SR 400 WB from  
North of Morgan Street to West of N 12<sup>th</sup> Street  
Hillsborough County, Florida**

**WPI Segment No.: 445056-2**

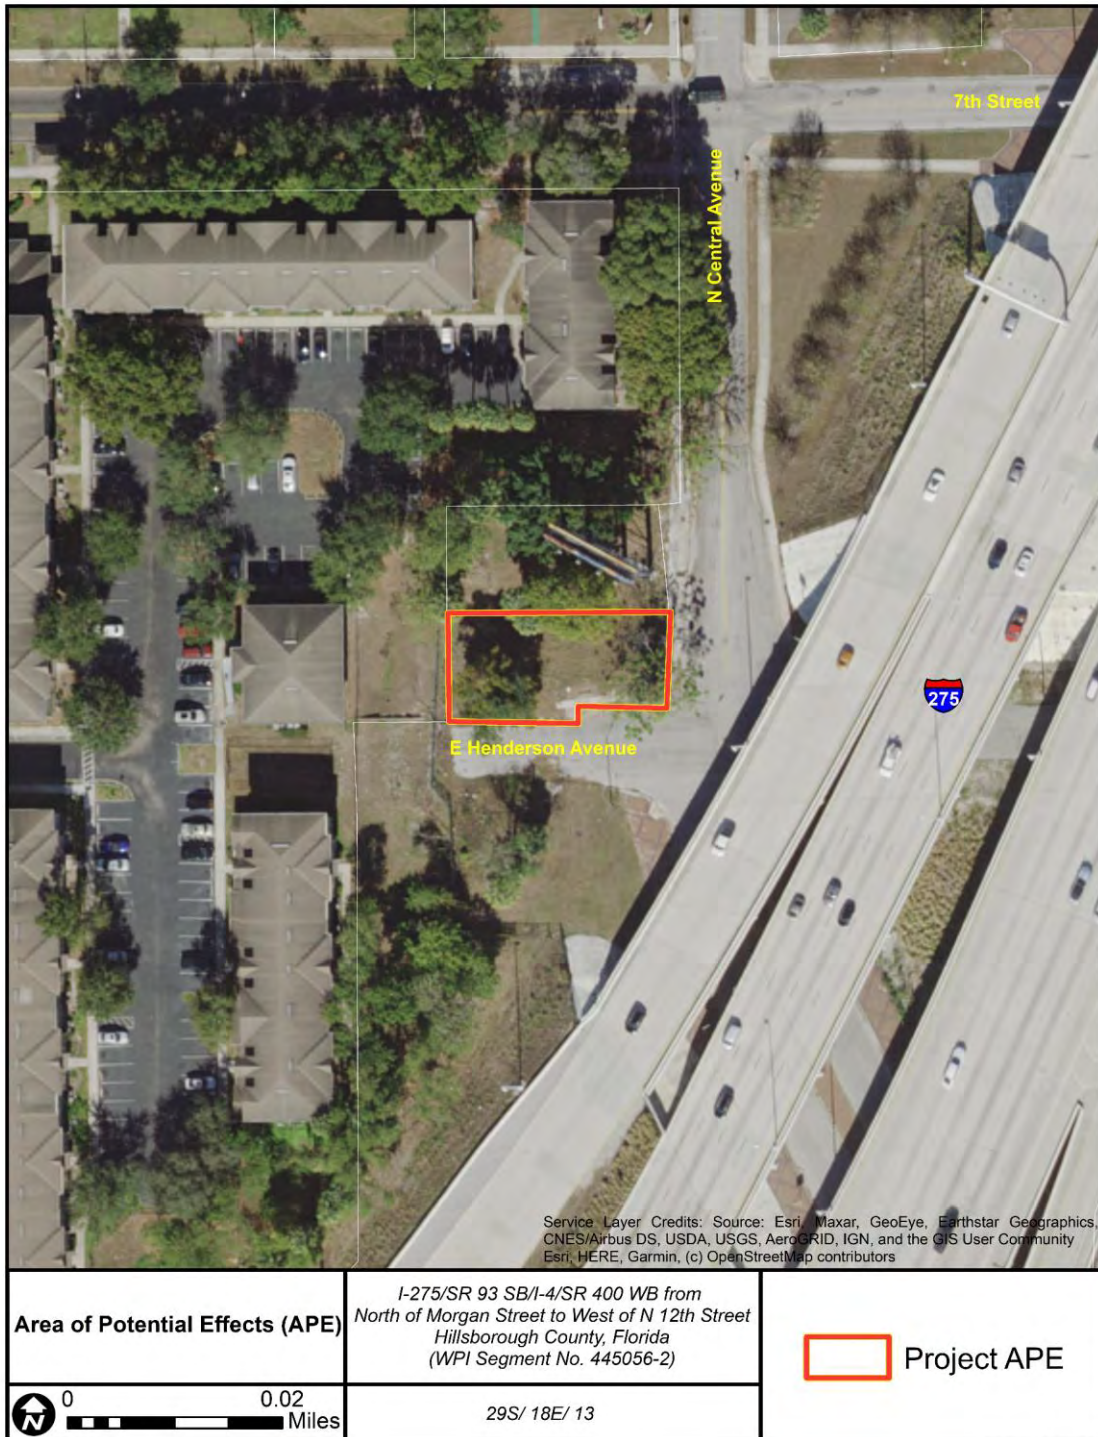
**Figure 2: Area of Potential Effects**  
 (Source: ESRI, 2021)

As defined in 36 CFR Part § 800.16(d), the APE is the “geographic area or areas within which an undertaking may directly or indirectly cause alterations in the character or use of historic properties, if any such properties exist.” Based upon the scale and nature of the activities, the archaeological and historic resources APE has been limited to the footprint of the proposed ROW acquisition (entire parcel located at 1702 N Central Avenue) (**Figure 2**). Due to the nature of the proposed work, this project will have no potential to affect historic resources adjacent to, but outside the APE.

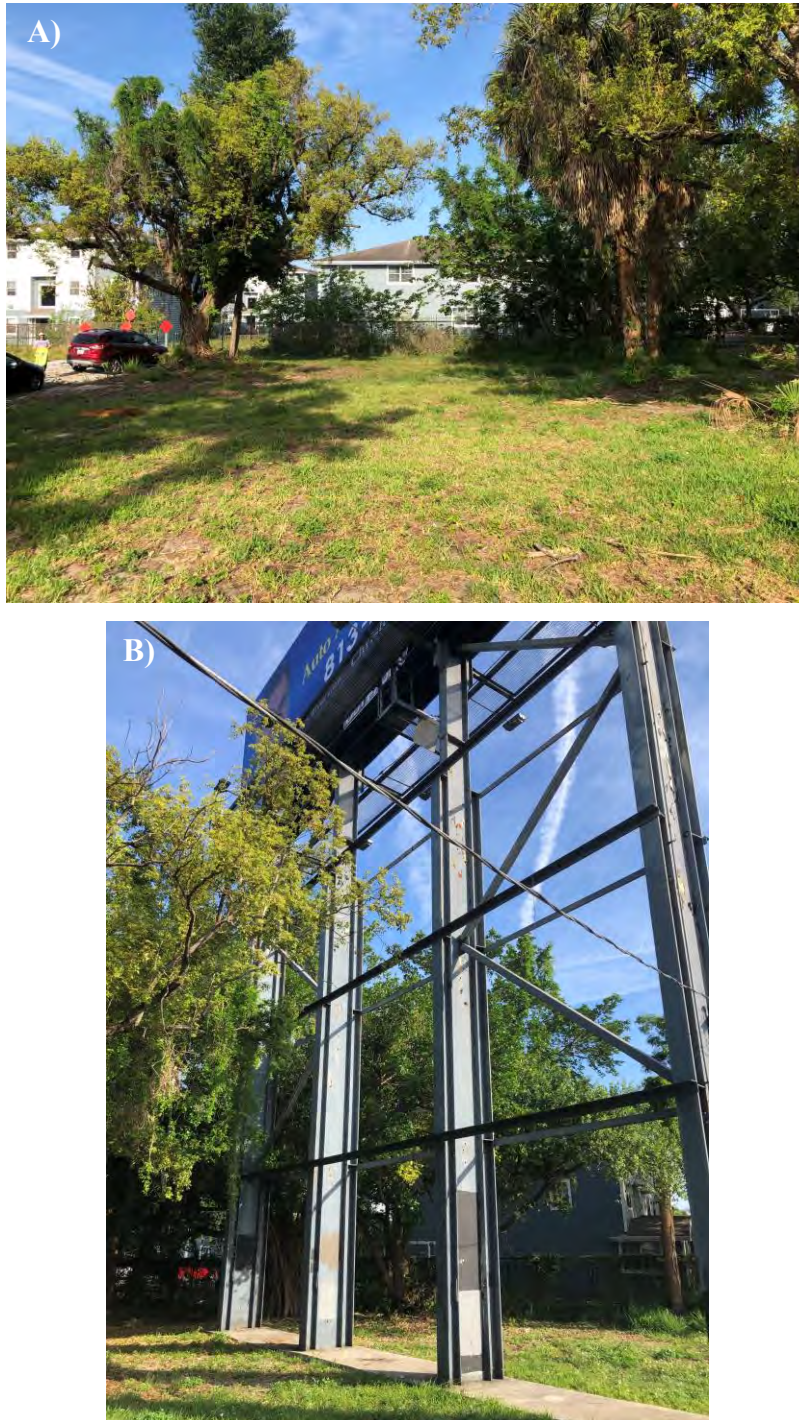
**Figure 4: Photos of the Project Area**  
(Photos Taken by Atkins During May 2021 Field Survey)

- A) Overview of the proposed ROW parcel, facing west;  
B) Billboard on immediately adjacent parcel, facing north

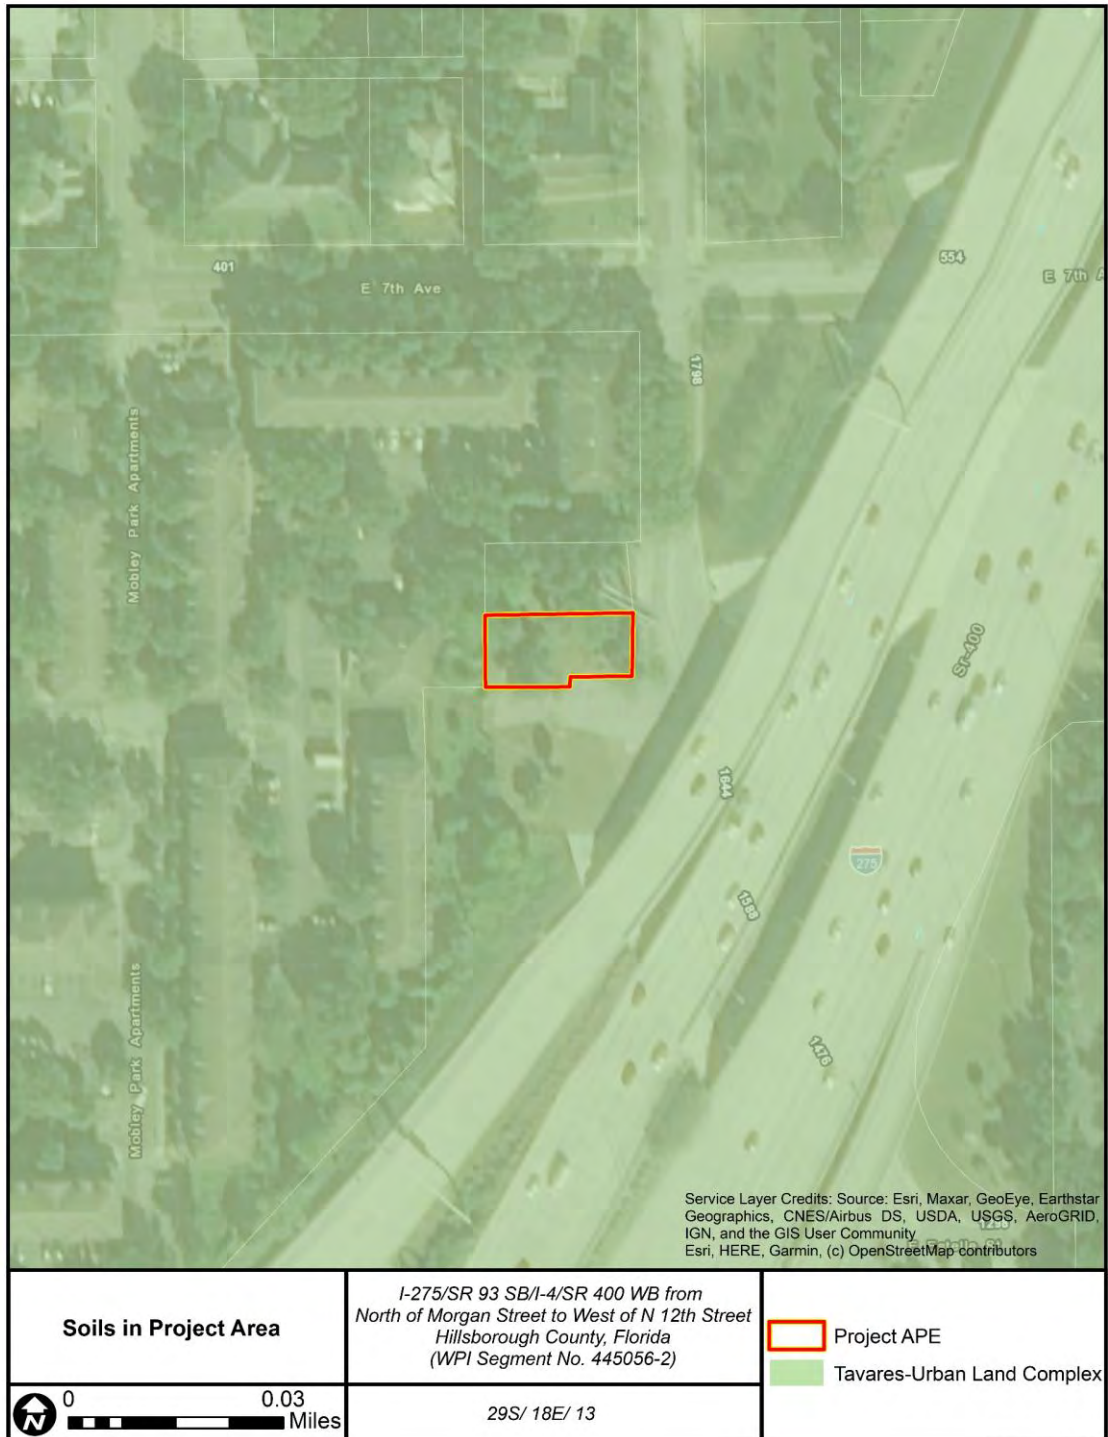
**Figure 5: Soils in Project Area**  
 (Sources: ESRI, 2021; USDA, 1994)

The project APE is located within the Southern Florida Flatwoods Major Land Resource Area (MLRA). Soils within the Southern Florida Flatwoods MLRA are typically poorly drained. Primary land uses within the Southern Florida Flatwoods, include pasture, rangeland, cropland, or woodland (Ford et al. 1990). However, throughout the proceeding decades, land-use across Hillsborough County has shifted towards greater commercial and residential uses. The project APE is comprised of Entisols, specifically soils belonging to the Tavares soil series (**Figure 5**).

Tavares-Urban Land: Soils belonging to the Tavares soil series are moderately well drained and form in sandy marine or eolian deposits. These soils tend to have very deep, well defined stratigraphic profiles and are typically found on hills, rides, and knolls. Slopes within these areas generally range from 0 to 8 percent. Natural vegetation consists of slash pine, longleaf pine, blackjack oak, turkey oak, and post oak (National Cooperative Soil Survey 2018). The soils within the project APE have been heavily altered by anthropogenic disturbances and are now more aptly classified as Tavares-Urban Land.

The “Urban Land” soil series designation refers to soils in urban areas that have been heavily disturbed by anthropogenic activity. Urban Land soils form through the mixing of numerous parent materials and cannot be distinctly classified into any other soil series. The stratigraphic profile in areas with this designation has been significantly disturbed, making it unlikely that any in situ archaeological material is present. Within the APE, most native vegetation has been removed for residential development. Today, the stratigraphic profile exhibits a significant degree of mixing resulting from the demolition of the structure once located on the parcel (See *Section 6.0 Survey Results*).

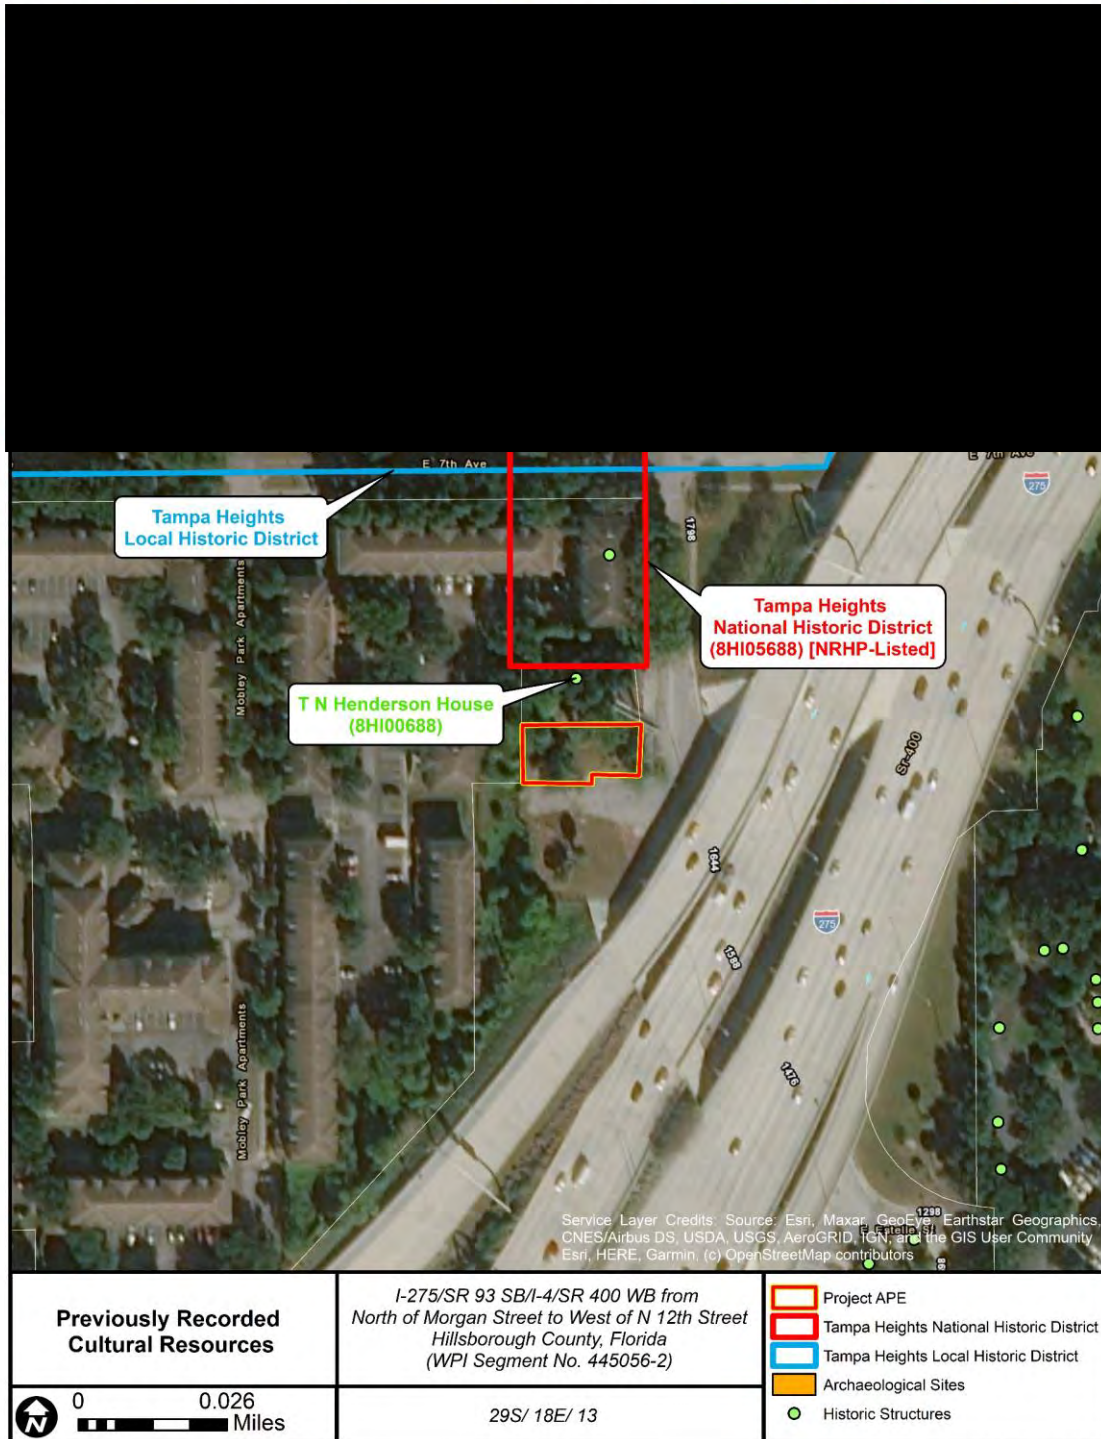
**Figure 6: Previously Recorded Cultural Resources**  
 (Sources: ESRI, 2021; FMSF, 2021)

A review of the FMSF data did not identify any previously recorded archaeological sites within or immediately adjacent to the project APE (**Figure 6**). However, there are four archaeological sites (8HI00848B, 8HI00849B, 8HI00917B, and 8HI03705B) within 200 meters (m) of the APE. All four of these sites are associated with early 20<sup>th</sup> Century structures and were determined NRHP ineligible by the SHPO on October 27, 1993. A review of historic maps, including USGS Quadrangle Maps, Sanborn Maps, survey plat maps, and historic aerials revealed that an early 20<sup>th</sup> Century structure was once present within the APE (1702 N Central Avenue).

A review of the FMSF data didn't identify any previously recorded historic structures within the APE. There is one previously recorded historic structure (T N Henderson House/ 1708 N Central Ave [8HI00688] - Demolished) adjacent to, but outside the APE (**Figure 6**). There are no historic age parcels (i.e. constructed in 1972 or earlier) adjacent to the APE. Additionally, the project area is located just south of the Tampa Heights Historic District (8HI05688) (**Figure 6**). This design segment was included in the previous TIS FEIS and TIS SEIS CRAS documents described above which included a historic resources survey of the overall TIS SEIS APE. The current CRAS Update is only focused on the one proposed ROW parcel for this design segment.

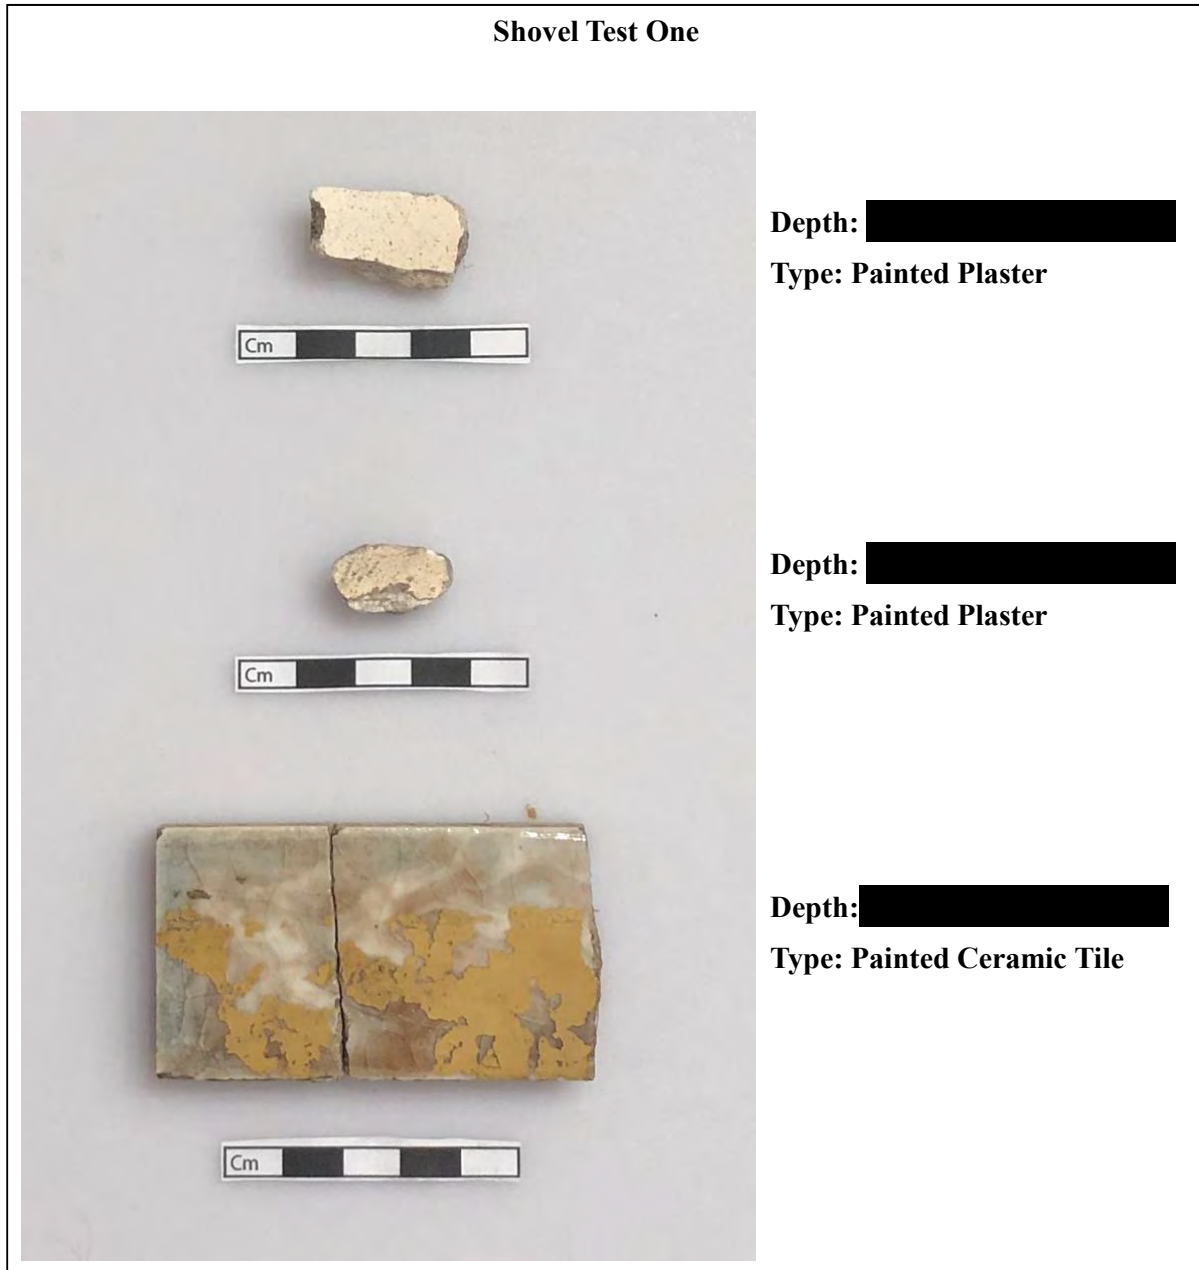
Shovel test one (ST1) revealed evidence of [REDACTED]

**Figure 13: Artifacts Recovered from ST1**

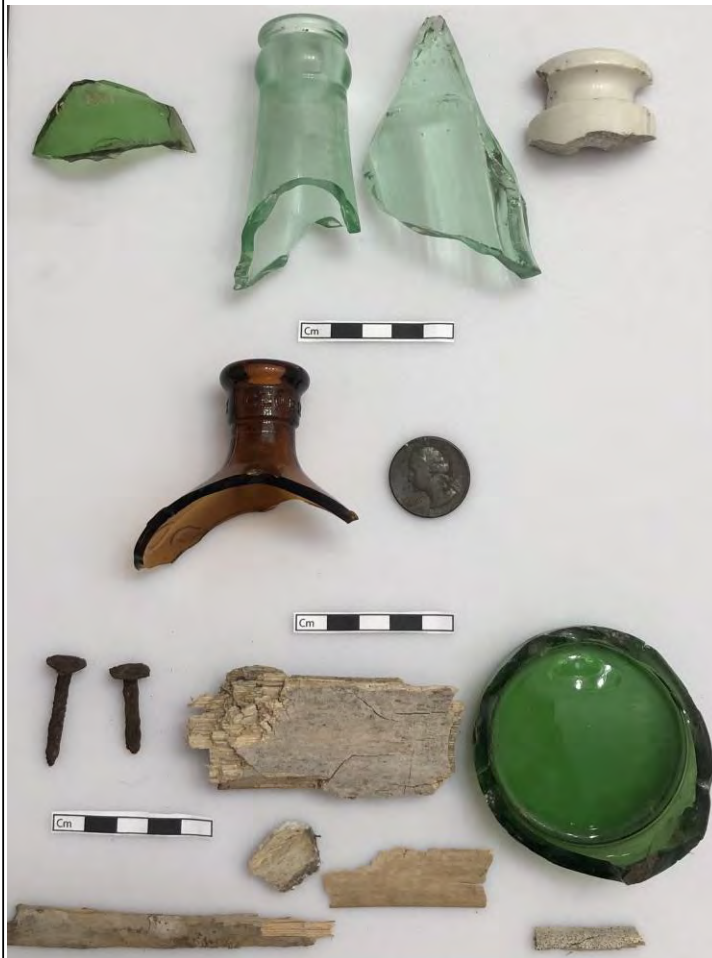
Shovel test two (ST2) revealed evidence of a severely mixed stratigraphic context.

Types: Glass and Ceramic  
Vessels

Types: Glass Clorox bottle (ca.  
1930's) and 1965  
Quarter

Types: Painted wood, green  
glass bottle base, iron  
nails, painted plaster

Figure 14: Artifacts Recovered from ST2

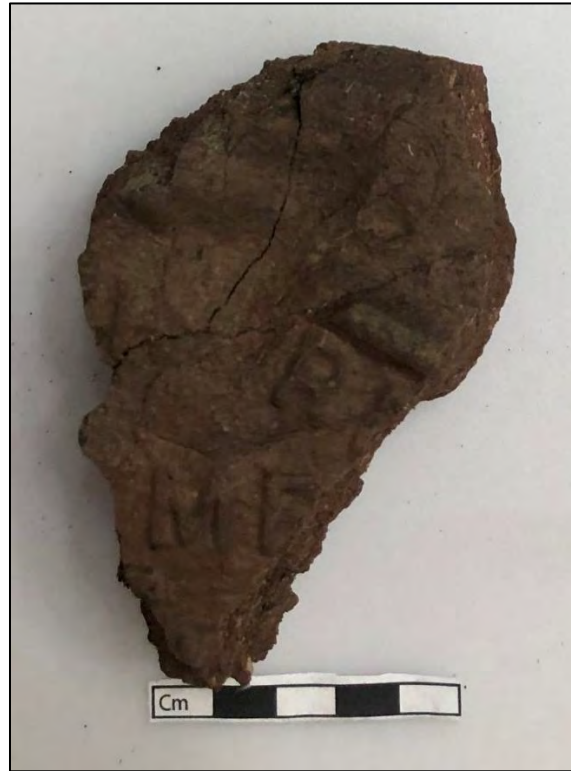
**Figure 16: Brick with partial stamp recovered near ST3**

Numerous surface finds and features were encountered across the site. Most notably, a brick with partial stamp (**Figure 16**) and a yellow painted brick (**Figure 17**) were recovered [REDACTED] (**Figure 18**)

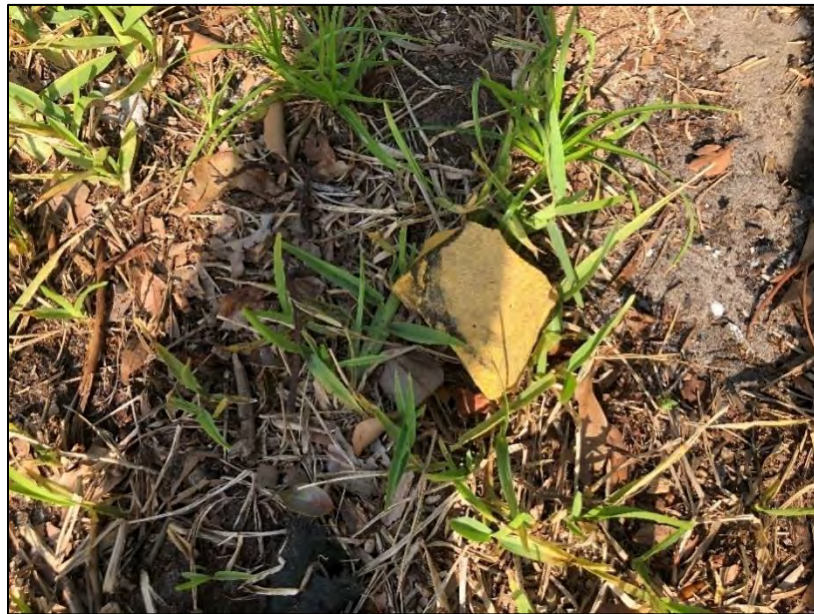
**Figure 17: Painted Yellow Brick Recovered Near ST3**
