### **APPENDIX G**

Colorized Exhibits
of the Plans for
TIS FEIS
Long Term Preferred
Alternative

#### TAMPA INTERSTATE STUDY

# **Bridge Rehabilitation Recommendations Memo**

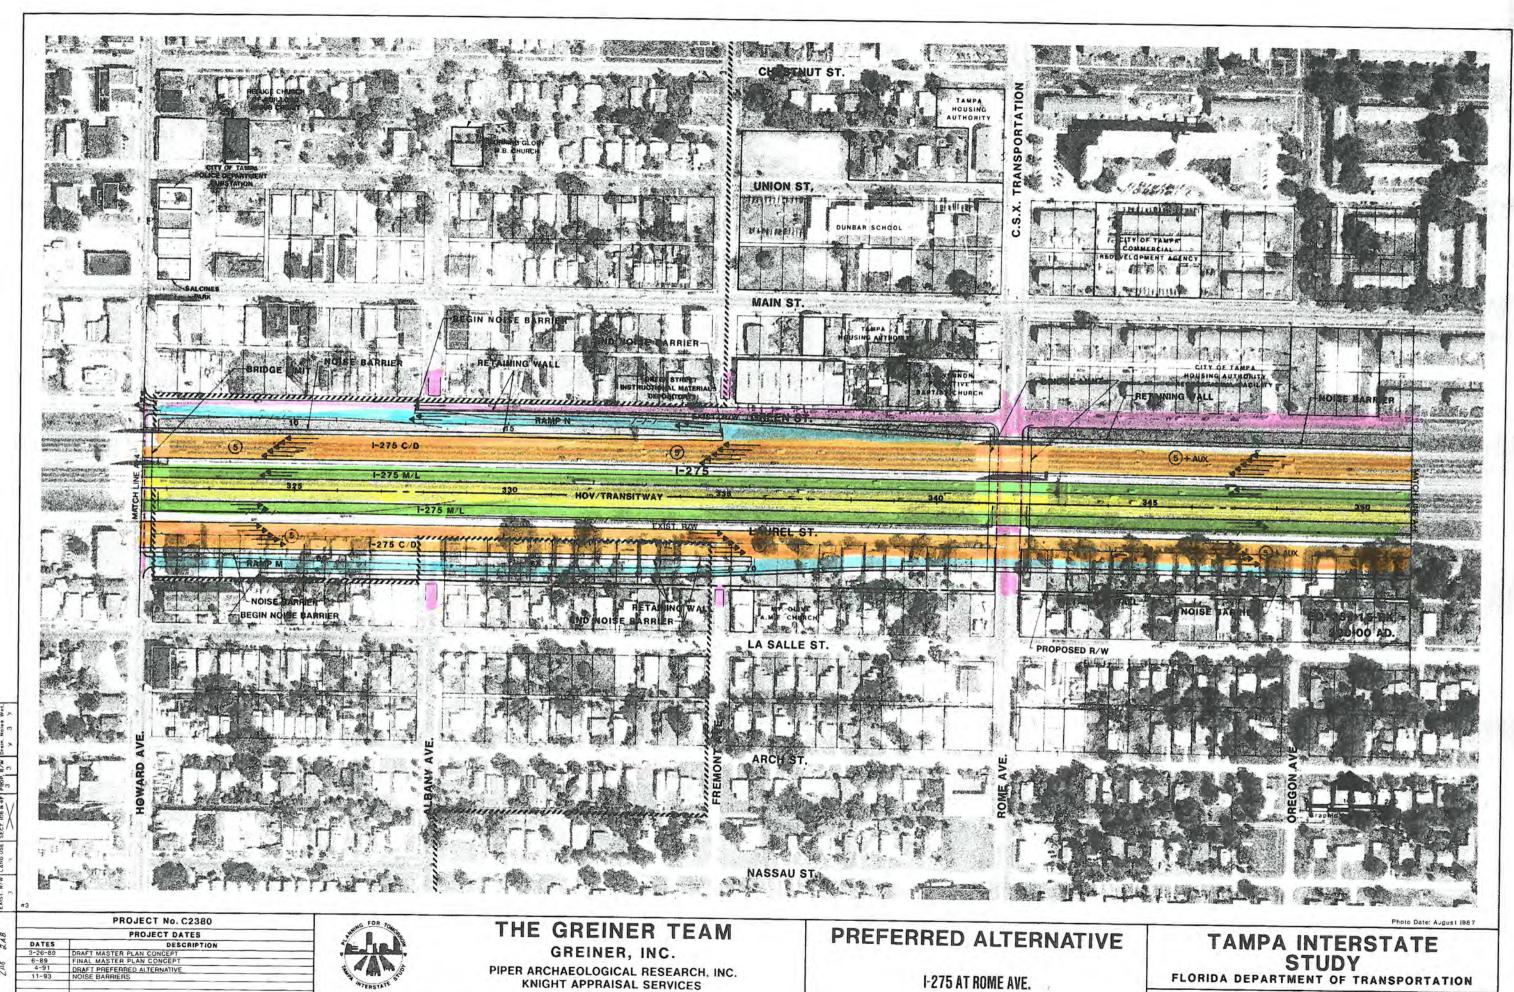
FLORIDA DEPARTMENT OF TRANSPORTATION STATE PROJECT No. 99007-1402 SHEET A-5 OF 31

1-275 AT ROME AVE.

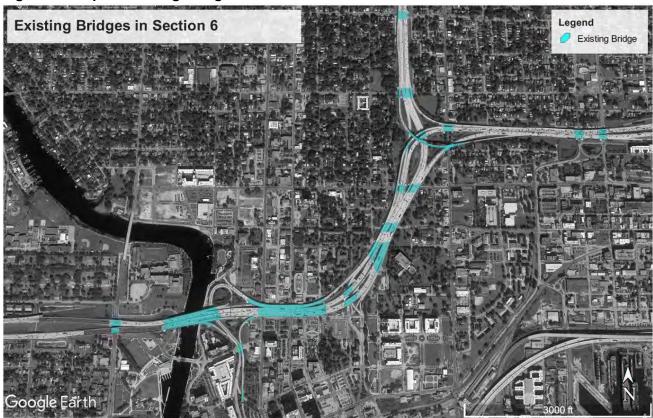
Figure 1: Map of Existing Bridges in Section 6 **Existing Bridges in Section 6** Legend Existing Bridge

The purpose of this memo is to summarize the findings of a structural review of the existing bridge structures within Section 6 of the Tampa Bay Next (TBN) Program (see *Table 1* and *Figure 1*), make a recommendation on potential rehabilitation of existing bridges, and provide a cost estimate for potential deck replacements. The Section 6 bridges included in this memo are within the downtown interchange of I-275 and I-4 from Floribraska Avenue to the north, North Boulevard to the south and west, and 15<sup>th</sup> Avenue to the east. The review considers only structural issues and does not consider the current or future geometrics of the mainline or cross streets.

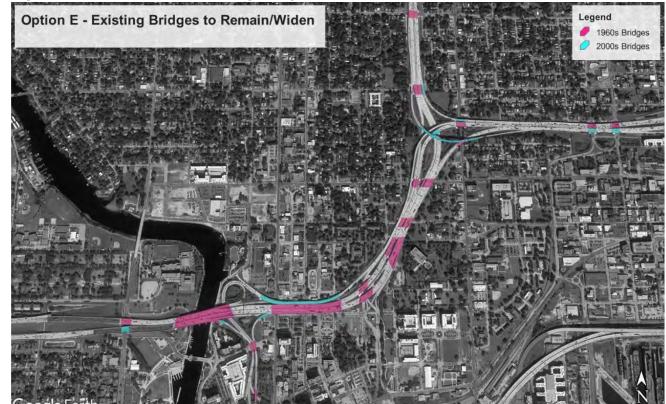
Figure 4: Map of Option E Existing Bridges to Remain/Widen Option E - Existing Bridges to Remain/Widen Legend 1960s Bridges 2000s Bridges

Since Design Option E does not include express lanes and would not provide additional travel lane capacity to mitigate traffic impacts, only Bridge Nos. 100139 and 100141 would include deck replacement as part of the construction project at a cost of \$3 million. Deck replacement for the remaining bridges would be included in a separate rehabilitation project at a cost of \$59 million.

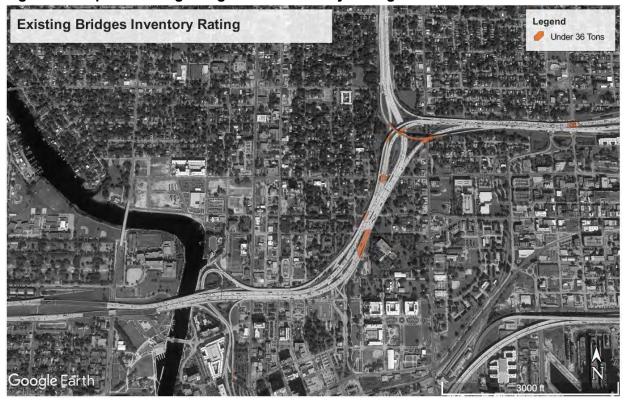
Figure 7: Map of Existing Bridges with Inventory Rating Under 36 Tons

load rating capacities; additional analysis is recommended to investigate the load capacity of this bridge.

Through this review, 17 bridges have been identified as having insufficient load capacity; 10 of these are being recommended for widening in Design Options C, D and E and six more are candidates for deck replacements. Eight bridges have deck, substructure, or superstructure ratings of "6-Satisfactory". Performing repairs to the structures may improve their structural condition ratings; though strengthening may be required to increase the load capacity. Per the FDOT District 7 maintenance staff, in the event deck strengthening or additional deck overlays are considered as potential rehabilitation, then beam strengthening should also be considered.
